# HOSPITAL RADIOTHERAPY ROOF REFURBISHED WITH BELZONA

ID: 6108

2000m<sup>2</sup> felt roof spanning Radiotherapy Department.

Hospital, Teesside, UK

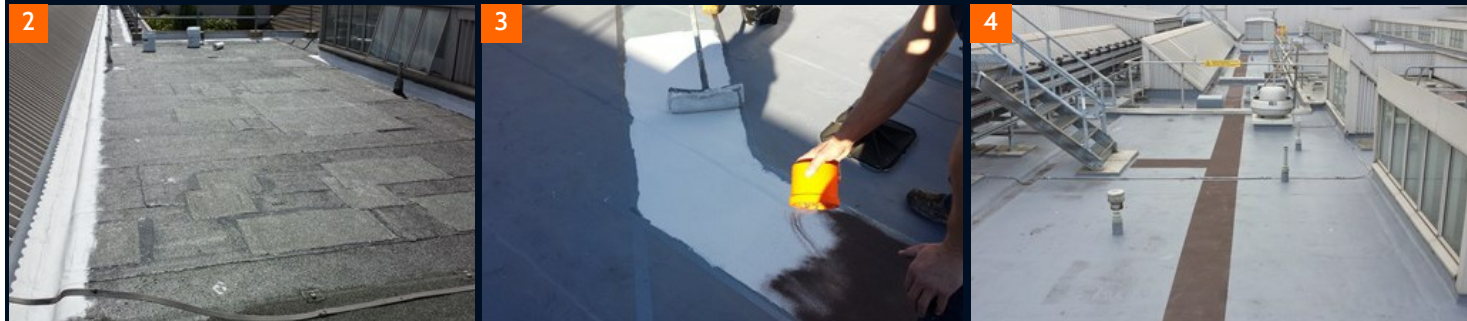
The aged felt had been patched many times in the past, but leaks persisted and so they wanted a long term solution that would have minimal impact on the hospital and public visitors. There was also a lot of roof furniture over the roof including cable trays, AC units, pipe racks and foot bridges that would have made installation of new felt or a single ply membrane impossible.

1. Section of roof from original inspection
2. Application of Belzona 3111 underway
3. Application to walkway with Belzona 9231 aggregate
4. Completed refurbishment

Application was carried out in accordance with Belzona Know-How System Leaflets RPA-6 and RPA-8. A further coat of Belzona 3111 was used to add a walkway across the roof.

The Belzona 3111 has a BBA certificate with an assumed working life of 25 years, which gave the client the confidence in the system. As the membrane is lightweight, it can be applied directly onto the existing substrates, with no need to remove the aged felt. The water based material allowed application to continue throughout the day with no odours being detected by the public or staff. In addition, the materials are all liquid applied and so it can easily encapsulate all of the difficult furniture to create a seamless flexible roof membrane, with a simple brush application.
