# BELZONA COLD APPLIED ROOFING FOR SUBSTATION

ID: 6110

Substation flat asphalt roof and plant room waterproofing.

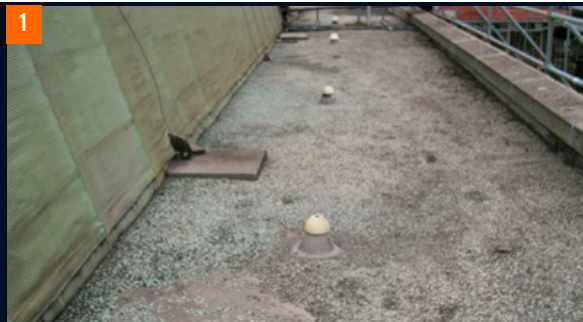
The client had a series of aged asphalt roofs around the facilities that were leaking. On this Substation there was also a copper clad plant room that was leaking around the edges. Renewing the asphalt would have been impossible due to the complexity of the roof and any hot works on the site was prohibited.

1. Substation flat roof
2. Asphalt de-chipped and application started
3. Completed roof protected with Belzona 3131
