# BELZONA SAVES ROOFING CONTRACTORS REPUTATION

ID: 6116

Roof felt on flat roof gutters.

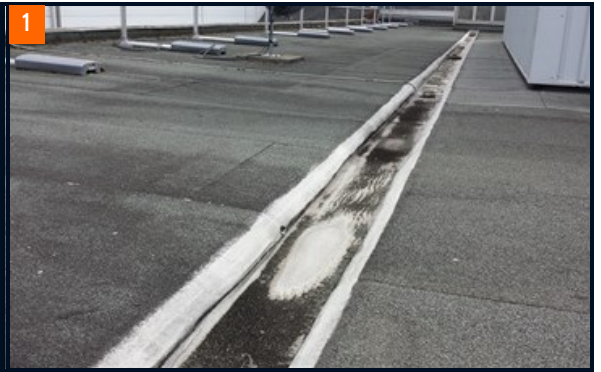
Multiple rips along the gutter due to the existing material not being flexible enough.

Roof gutter on initial inspection.

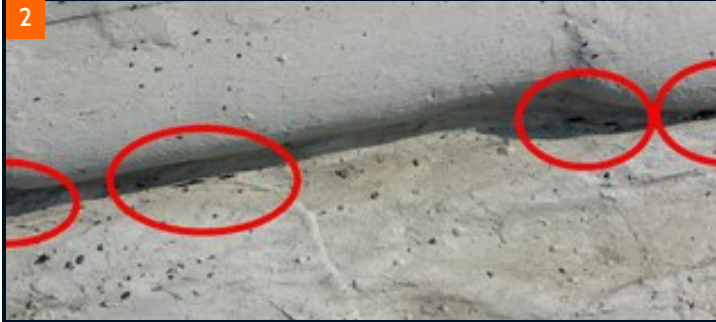
This flat roof gutter had been leaking previously and in an attempt to solve the problem the contractor had used a competitive material that proclaimed itself to be a highly flexible membrane. In fact, the contractor had used the same product on several roofs in the hospital and most had failed. The contractor was getting no support from the material manufacturer and he was worried for his reputation with this important client. For this particular gutter section, the application had been repeated and the competitive product had again failed. Belzona were called in by the contractor to save his reputation and solve the leaks once and for all. On close inspection it could be seen that the competitive product was not flexible enough and there were dozens of small rips along the gutter.

Damage to competitive product close up.

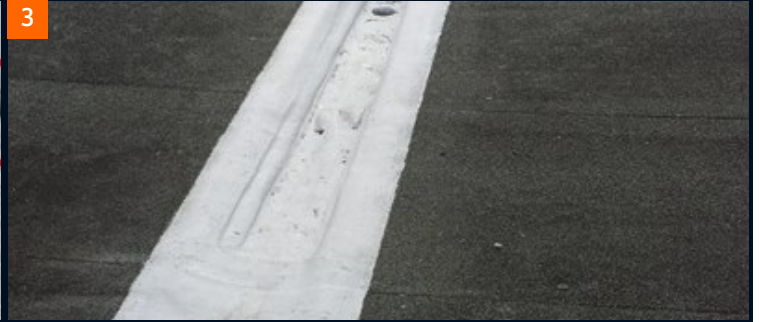
Completed Belzona 3111 application.

The Belzona membrane was applied directly onto the previous coating which reduced the costs and when the application was revisited 2 years later the Belzona was still perfect. Belzona have an excellent track record in supporting their materials and have been producing roofing materials since 1966. In the words of the contractor, "The cheaper competitive product had nearly destroyed our reputation and we would have never recovered without help from Belzona".
