# OFFSHORE PIPELINE INTERNALLY PROTECTED WITH BELZONA

ID: 6143

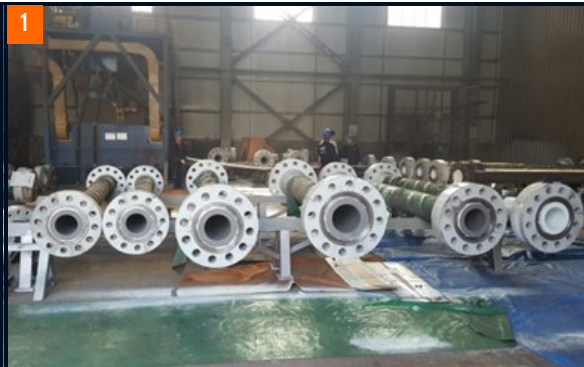
1. Pipe spools blasted and ready for coating 2. Spin-spraying underway using Belzona 1331 3. Integrity testing using High voltage spark test 4. Some of the spools inspected and finished

Application was carried out in accordance with Belzona System Leaflet VPF-2. Following surface preparation by grit blasting, the Belzona 1331 was applied directly onto the prepared surface using a plural feed heated airless spin-spray method.
