# BELZONA CREATES NON-SLIP SAFETY SURFACE IN FISH MARKET

ID: 6148

Fish market, Croatia

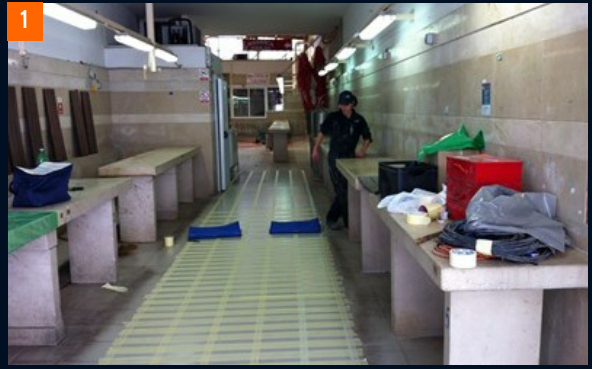
1. Situation in the fish market, positioning of masking tape 2. Surface preparation. 3. Application of Belzona 5231 with additional aggregate incorporated. 4. Application completed - situation after washing the floor
