# BELZONA SEALS HIGH RISE ROOF

ID: 6187

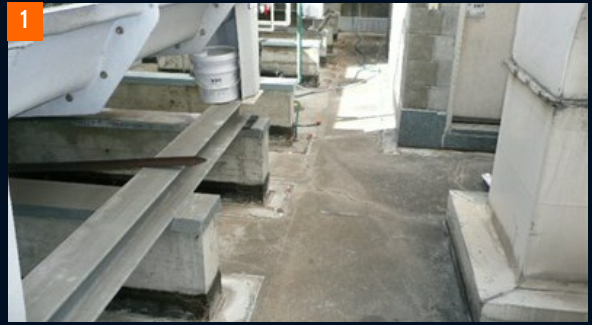
Water was leaking into the offices below and required a waterproof solution.

1. The roof prior to application 2. The finished coating 3. Alternate view of the sealed area

The application was carried out in accordance with Belzona System Leaflet RPA-1. The concrete was power washed to remove all dirt and detritus. Cracks that were revealed following the cleaning were then filled and sealed using Belzona 4151. The entire roof area was then coated with a fully reinforced Belzona 3111 system.
