# BELZONA REFURBISHES LOADING DOCK

ID: 6199

Loading dock and car park of a multi use business complex

Business complex, Brisbane, Queensland, Australia

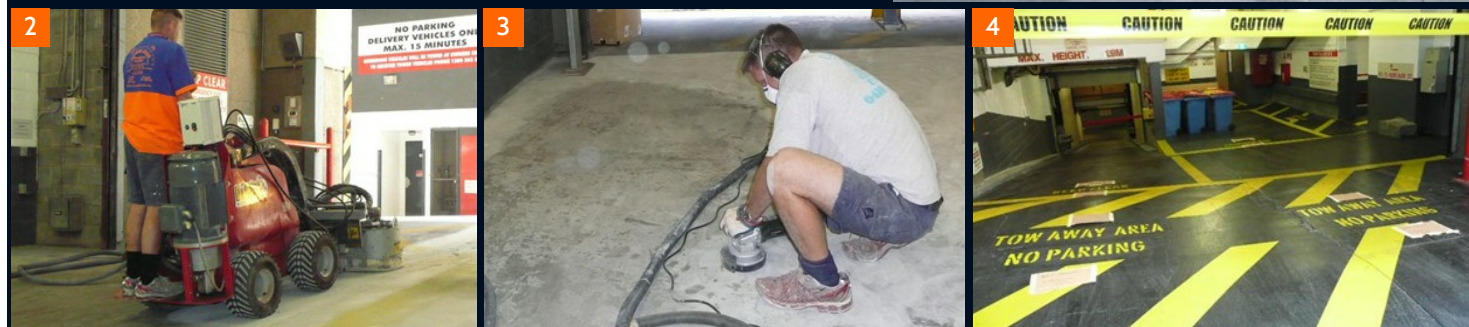
## PHOTOS

The Loading dock and car park were old and in need of a facelift as all of the original coating had been worn away.

1. The original condition of the floor area  
2. Surface preparation in progress  
3. A few small touch ups  
4. The finished application showing the coated floor and reinstated lines, wording and chevrons

The application was carried out in accordance with Belzona System Leaflets FPA-4 and FPA-8. The floor area was prepared using a dustless diamond grinder then coated with 2 coats of the Belzona 5231. The line markings, chevrons and wording were then reinstated using Belzona 4411 in a single coat of safety yellow.
