# NEW BELZONA FLOOR FOR NEW SHOWROOM

ID: 6280

New build flagship car showroom

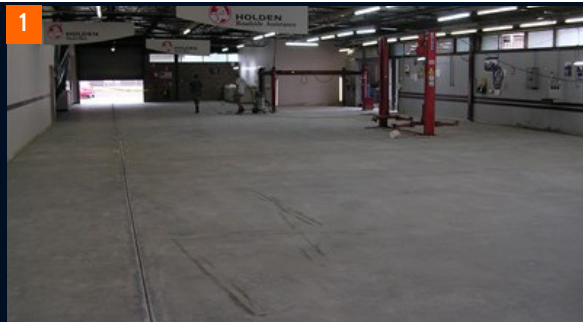
1. Floor prior to coating
2. Preparation complete, vacuuming up the dust
3. Application underway
4. Application complete and being inspected by the client

The application was carried out in accordance with Belzona System Leaflet FPA-3. The newly laid floor was allowed to dry out thoroughly before being prepared for coating by diamond grinding to remove surface laitence. After vacuuming to remove dust, the floor was coated with two coats of Belzona 5231.
