# BELZONA PROVIDES HYGIENIC WALLS

ID: 6285

Room in which sterile medical equipment is manufactured.

Medical equipment manufacturer, Poland

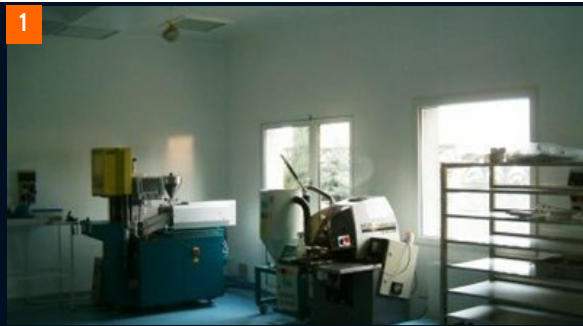
The previous coating on the walls did not withstand ultraviolet radiation, and liquid disinfectants used to create a sterile environment.

1. The room under renovation 2.,3.,4. The walls coated with Belzona 5111

The high gloss Belzona 5111 resists the germicidal lamps and liquid disinfectant used to create a sterile environment. Belzona 5111 is ideal for creating hygienic wall surfaces.
