# BELZONA RECASTS NEW PERIMETER EXPANSION JOINTS FOR OUTDOOR POOL

ID: 6288

The expansion joints of an outdoor pool

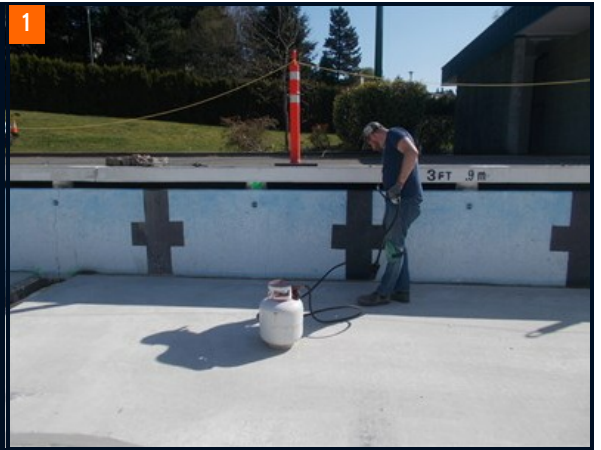
1.Joints needed to be dried out prior to casting

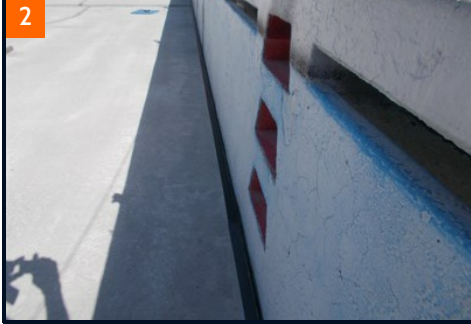
2.Joints masked off for a neat and tidy finish

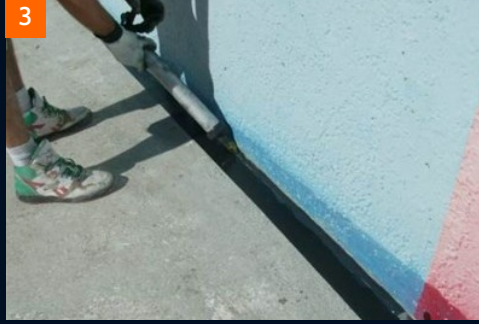
3.Injection of Belzona 2221 into expansion joint slot

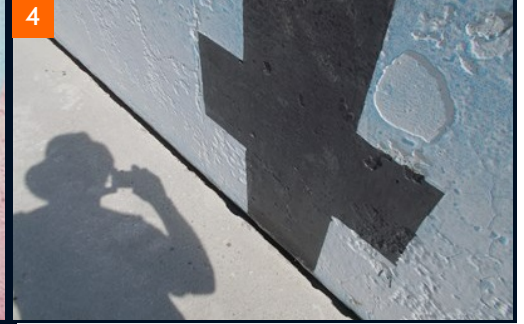
4.Completed joint.
