# BELZONA USED ON FERRY WATER JET

ID: 630

Ferry water jet propulsion units

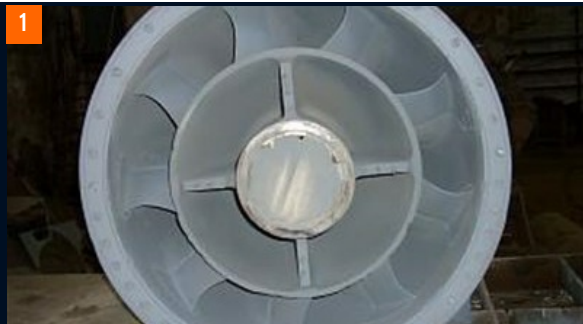
Units had significant erosion-corrosion.

1. Unit before coating
2. Application of Belzona
3. Finished application
