# BELZONA PROTECTS A NEW WASTE WATER PUMP AND IMPELLER FROM EROSION

ID: 6308

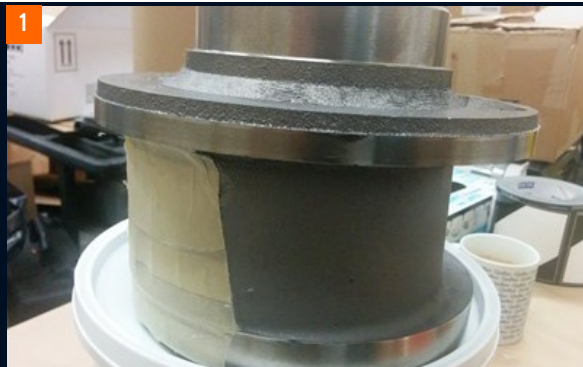
1. Impeller masked and abrasive blasted awaiting coating
2. Volute masked and abrasive blasted awaiting coating
3. Finished application of 1331 on impeller
4. Finished application of 1331 on volute

Belzona 1331 applied in accordance with the IFU and following the Belzona Know-How system leaflet CEP-03 for application of internal coatings for centrifugal pumps. The pump volute and impeller were masked off to protect machined surfaces and areas not requiring coating. The surface was then abrasive blasted to the required standard. The Belzona 1331 was applied as a two coat system. The first coat (Grey) was applied by brush at a DFT of 15 mils (375 Microns), followed by a second coat (white) also applied by brush at a DFT of 15 mils (375 microns).
