# BELZONA FLOOR COATING SYSTEM PROTECTS COMMERCIAL TRUCK LIFT ELEVATOR FLOOR

ID: 6317

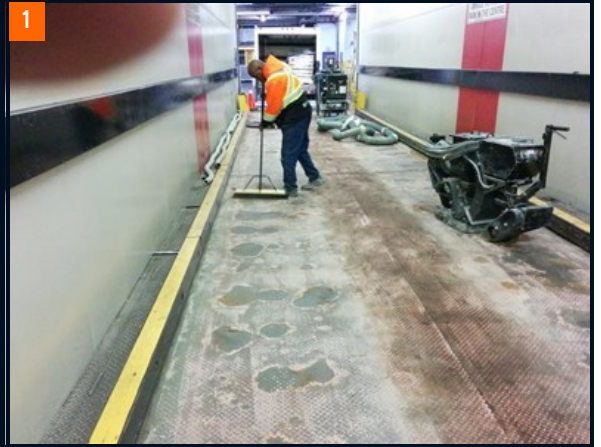
1. Truck elevator existing screed coating being removed and surface prepared
2. Damaged screed and corroded substrate
3. Belzona 9232 being broadcast into Belzona 5231
4. Completed application with Belzona 5233 top coat

Belzona 5231, 9232 and 5233 were all applied in accordance with the Belzona 5233 IFU and following the Belzona know-How system leaflet FPA-08 application of non-slip safety surfaces for floors. The substrate was abrasive blasted to the required standard, removing the failed screed material. The Belzona 5231 was applied by roller at a DFT of 10 mils (250 Microns), whilst wet Belzona 9232 was broadcast to rejection into the Belzona 5231. Once cured the excess Belzona 9232 was swept and vacuumed away and the top coat of Belzona 5233 applied by roller.

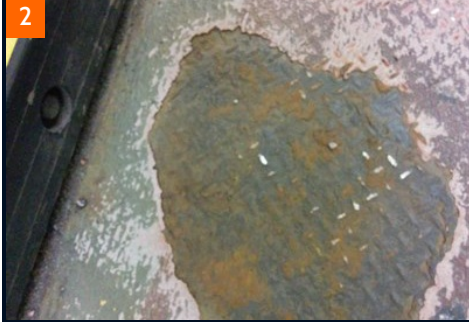
Existing screed flooring covering a steel checker plate floor had failed due to a combination of corrosion, chemical attack (Road salt in winter), traffic load and movement. The failing screed had chipped off and was allowing the steel substrate to corrode. There were also concerns over cleanliness and slip & fall safety.
