# BELZONA REPAIRS STEPS AT A SCHOOL

ID: 6333

Steps at a school

School District, Blue Springs, Missouri

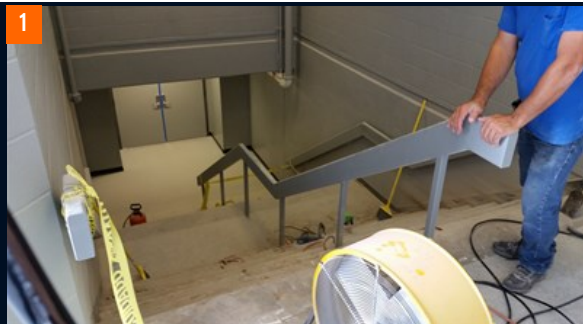
The vinyl treads of steps at this busy school were badly worn after just one year of service. The vinyl was wearing through at the step edges (nosings) and delaminating slightly on the stair treads, causing a trip hazard. Replacement was costly and would not provide the longer term solution this school was looking for.

1. Vinyl removed and glue scraped
2. Applying Belzona 4111
3. Belzona 4411 added to highlight step changes
4. Inspection after 18 months revealed them to be in perfect condition

The glued down treads were removed and the concrete was prepared and spot repaired with Belzona 4111. Belzona 5231 broadcasted with locally sourced aggregate was applied, followed by a top coat of Belzona 5233 to completely seal and ease the cleaning of the treads. Belzona 4411 applied to highlight step changes with its safety yellow color. A modified FPA-8 system leaflet was followed.

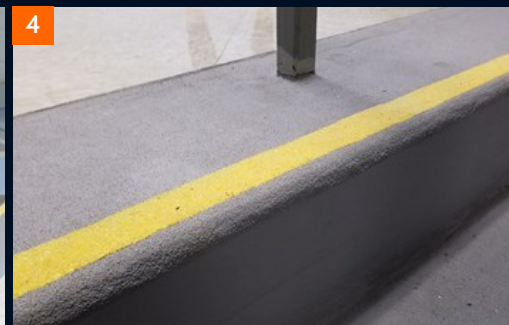
The project was accomplished in two days from start to finish and ready for pedestrian traffic the next day, with no odor. Belzona's solution was 1/4 the replacement cost of vinyl treads and proved to be cost-effective in the long term as well. Inspection after 18 months revealed the stairs to be in perfect condition, with the local Belzona Distributor saying that the stairs looked brand new, with no scratches and no wear on the treads or edges. The school's Associate Principle said that when they are properly cleaned, the stair look really good.
