# BELZONA REBUILDS SECONDARY CHEMICAL CONTAINMENT

ID: 6353

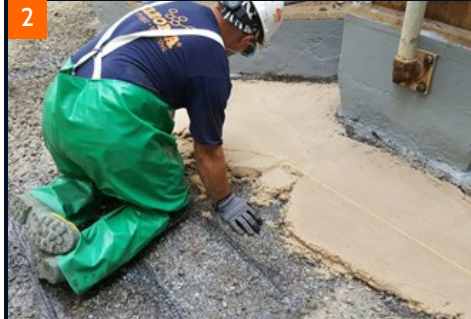
Repeated contact with caustic and hydrochloric acid over a period of years had caused serious damage to the concrete floor, tank and pump support bases.

1. Damaged concrete showing depth below grade.
2. Belzona 4154 being used to fill deeply eroded area.
3. Final grade with Belzona 4131 (Magma-Screed).
4. Final coat with Belzona 5811 and broadcast aggregate.

The application was carried out in accordance with Belzona System Leaflets TCC-9 and TCC-15. Damaged and loose concrete was removed and the entire area was high pressure water washed. PH testing was carried out and the area verified neutral after washing. When dry the eroded vertical surfaces of the tank and pump support bases were rebuilt with Belzona 4141 (Magma-Build). The deeply eroded areas of the concrete floor were filled to within approximately 1/4" of the final grade using Belzona 4154 (Bulkfill Resin) and sand. The final grade required for proper drainage was achieved using Belzona 4131 (Magma-Screed). The entire area was protected with Belzona 5811 with a light broadcast coat of aggregate for slip-resistance.
