# BELZONA SAVES GULF OF MEXICO FROM POTENTIAL OIL SPILLAGE

ID: 6377

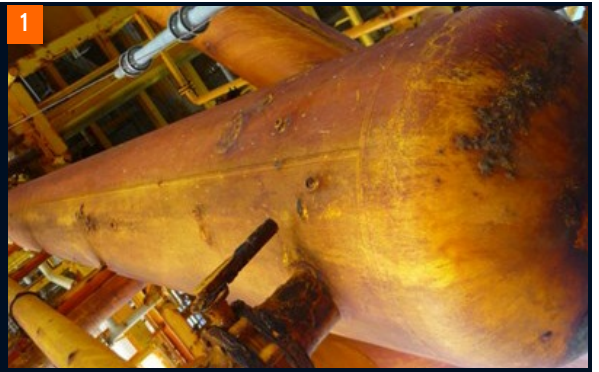
1. Blistered and corroding sump pile.
2. Through wall defect discovered during blasting operations.
3. Defective area plugged with wood and Belzona 9611 to reduce leak.
4. Cold plate bonding repair with Belzona 1161.

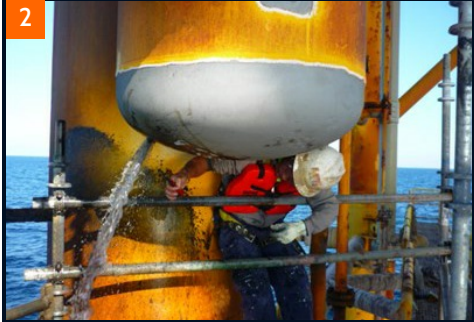
The customer had a blasting and painting contractor on board to carry out routine work. While abrasive blasting a sump, a large through wall defect was discovered.
