# BELZONA 1593 LINING PROTECTION OF LIQUID- LIQUID HYDROCYCLONE

ID: 6391

Newly fabricated liquid-liquid hydrocyclone to be protected against corrosion.

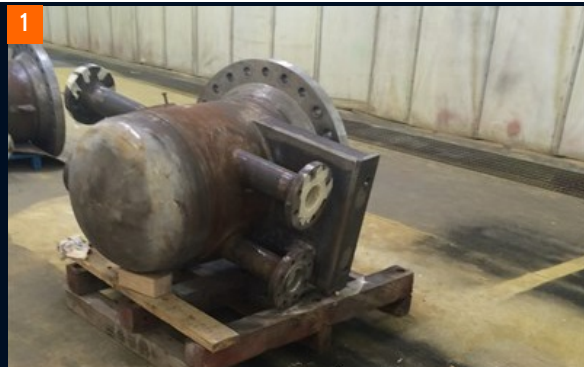
- 1.Before Grit Blasting
- 2.Application of the 2nd coat of Belzona1593 in light grey
- 3.HVT Testing
- 4.Completed Application

Application was carried out in accordance with Belzona Know-How System Leaflet TCC-5 for protecting steelwork. After grit blasting to achieve Sa2.5 (SSPC-SP10) , Belzona 1511 was used to smoothen the welding areas with poor finish and a two-coat system of Belzona 1593 was brush-applied to the vessel surface.
