# BELZONA SOLUTION FOR TRICKY PIPE PENETRATION

ID: 6410

## PROBLEM

Pipe penetration was allowing rain water to leak through the wall into workspaces at a local hospital.

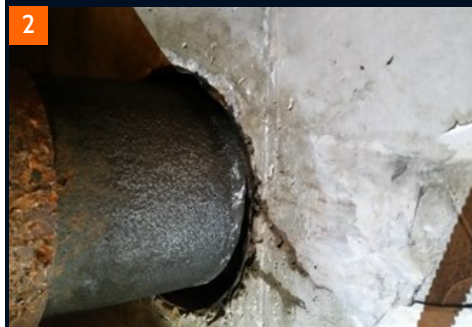
The pipe penetration is in a basement wall above the suspended ceiling. The exterior of the wall is under 10 feet of earth and concrete so the customer needed a way to solve the leak from the inside of the wall. They also needed a solution that would work with multiple substrates.

1) Leaking pipe penetration with remnants of previous repair attempts using caulk and plaster 2) Pipe and concrete cleaned and ready for conditioning 3) Conditioned area ready for application of Belzona 2211, a foam filler was used as a backer in the area between the wall and the pipe 4) Application complete with a flexible two layer "boot" that is seamlessly adhered to the pipe and wall

Application was carried out using knowledge gained from Belzona System Leaflets GSS-3 and RPA-8. Application area was cleaned using a bristle blaster and concrete grinding disc. A foam filler was applied between the pipe and the wall to act as a backer during the application. Area was conditioned with Belzona 2911 and edges were taped to keep the application within the conditioned area. Belzona 2211 with embedded Belzona 9341 was applied as the first layer and tape was removed. Approximately 90 minutes later the edges were re-taped and a second layer of Belzona 2211 was applied to complete the repair.
