# BELZONA SLOWS ABRASION TO A CRAWL

ID: 6414

Blast pot used in the customers pneumatic conveyor system was being worn through.

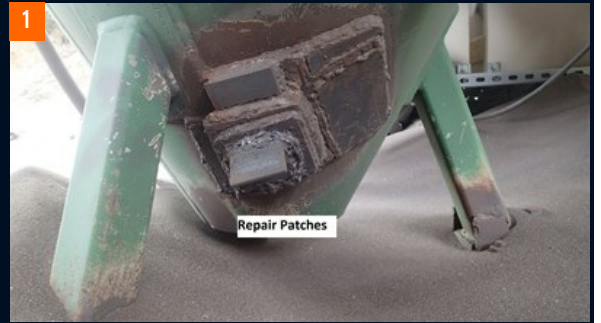
Customer uses pneumatic conveying system to move sand throughout their large facility, this blast pot was being repaired constantly as pressurized air combined with the sand in system to abrade holes in the pot opposite port into which air was injected. New equipment was only lasting a few weeks before needing to be patched and after than needed constant repair.

- 1) Blast pot with patch on top of patch, the previous solution
- 2) Impact area inside pot prepped for application
- 3) Application of Belzona 1812 in progress
- 4) Application Complete
