# BELZONA EXPANSION JOINTS A BETTER SOLUTION

ID: 6415

Nashville Tennessee Convention Center

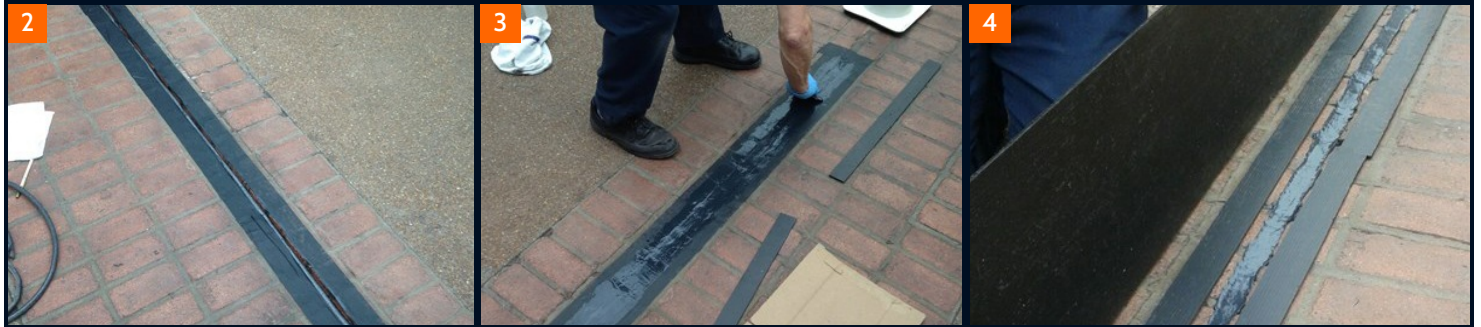
## PHOTOS

1) Joint edges ground and cleaned to remove old adhesives and loose material  
2) Joint edges taped and conditioned  
3) Application in process  
4) Application completed

Application was carried out in accordance with Belzona System Leaflet FPA-6. Old caulk and filler material was removed and the joint edges were ground with a masonry disc to insure a bond to firm substrate. Loose material was cleaned away and a solvent wipe was used to remove dust. The edges of the joint were taped with gaffers tape to insure materials did not extend beyond the intended area of application. Backer rod was inserted into the gap and set at depth of 1/4". Belzona 2911 was used to condition the edges of the expansion joint. After allowing the Belzona 2911 to dry, Belzona 2211 was troweled into the joint, taking care to insure good contact at the edges of the joint. The joint was then allowed to cure before foot traffic was allowed to return to the surface. The joint application was split into two parts to allow pedestrian traffic to use one lane of the bridge during cure.
