# FULL PROTECTION OF DEHYDRATOR WITH BELZONA LINING AND NOZZLE INSERTS

ID: 6449

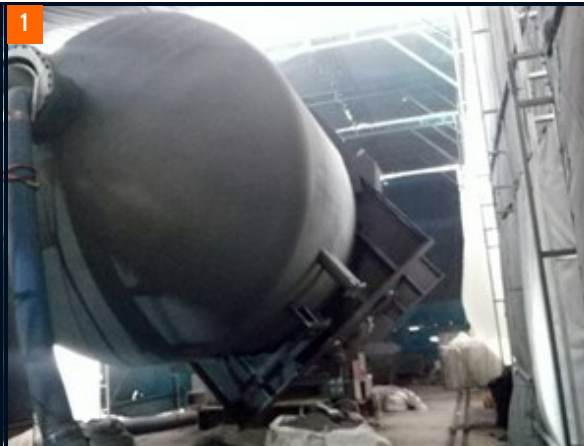
- 1.Grit blasting to Near White Metal cleanliness levels
2. Placing the nozzle inserts
3. Application of the second coat
4. Inspecting for holidays or discontinuities via spark testing

Application was carried out in accordance with Belzona Know-How System Leaflet TCC-5 and TCC-16b . Pre-formed nozzle inserts were fabricated and bonded into small bore nozzles to ensure continuity of protection.
