# PLAYGROUND DECKING MADE SAFE WITH BELZONA

ID: 6456

School Playground

Primary School, Cleveland, UK

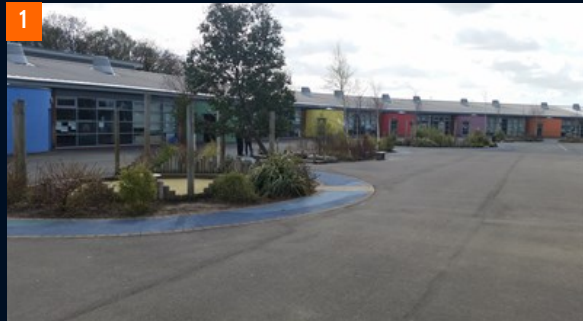
Wooden decking areas in the playground became very slippery in certain conditions. There had been an injury claim against the school so they wanted to retro-fit a grip system to make it safer for the children.

1. Playground overview
2. Applying the Belzona 5811/9211 mixture
3. Blinding with Belzona 9211 Supergrip
4. Detail of completed Application
