# FORMATION OF LOW PROFILE OIL CONTAINMENT TRAPS WITH BELZONA

ID: 660

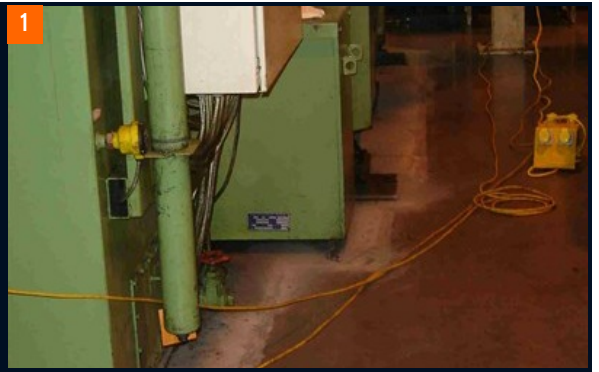
1. Agreed area around machinery prepared
2. Pipe removed Belzona 4111 trap formed
3. Finished job neat and effective

The area where the containment trap is to be created is carefully chosen so as not to create a potential trip hazard. The application is carried out in accordance with a modified version of Belzona Know-How System Leaflet TCC-9. Two-inch plastic pipe sections, cut in half length wise are used to form the Belzona® 4111 containment dam.
