# BELZONA ELASTOMERS USED FOR SWIMMING POOL EXPANSION JOINTS

ID: 661

Original expansion joint material was no longer effective

Expansion joints in Olympic size swimming pool

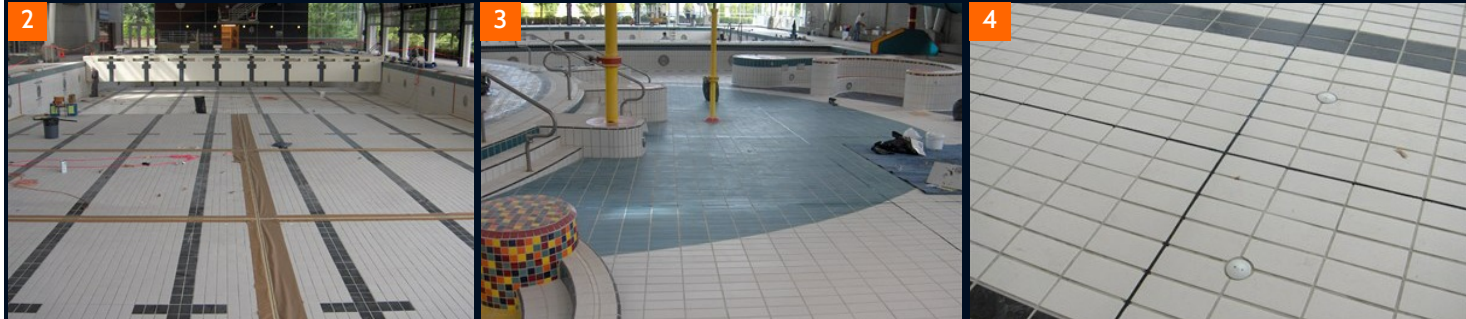
## PHOTOS

1. Preparation of expansion joints underway
2. Grinding completed and masking of joints underway
3. View of completed recreation section of the pool
4. Close up view of completed joint

Application was carried out in accordance with Belzona Know-How System Leaflet FPA-6

This pool required the sealing of approximately 3000 linear feet of jointing. Belzona Elastomers have built a history of longevity and durability in these types of applications spanning 8 years. This is now the 14th such application in British Columbia, Canada

Belzona 2211 (MP Hi-Build Elastomer)  
Belzona 2221 (MP Fluid Elastomer)
