# BELZONA PROTECTS SCREW CONVEYORS FROM EROSION

ID: 679

Protection of screw conveyors

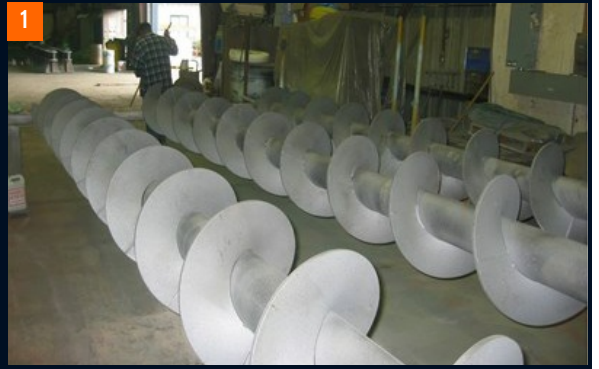
1. View of augers after blasting.
2. First auger masked off ready for application of first coat of Belzona 1321(Blue).
3. Application of first coat in progress.
4. Application of second coat of Belzona 1321 (Grey) completed with second auger masked off awaiting application.

Application carried out in accordance with Belzona Know-How System Leaflet SHM-14.
