# BELZONA 3111 FLEXIBLE MEMBRANE SEALS SKYLIGHTS - FINALLY!

ID: 686

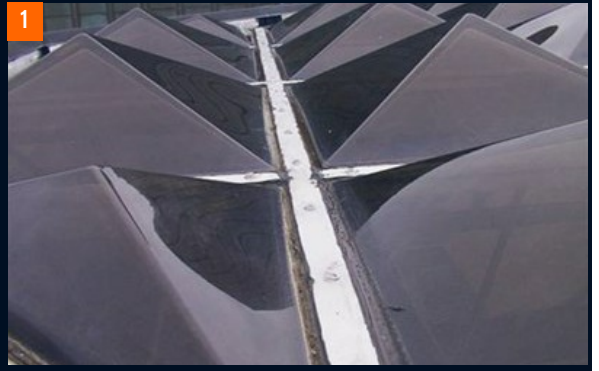
1. View of skylights showing roof design and gutter detail
2. A close up of one of the many problem areas
3. Completed application

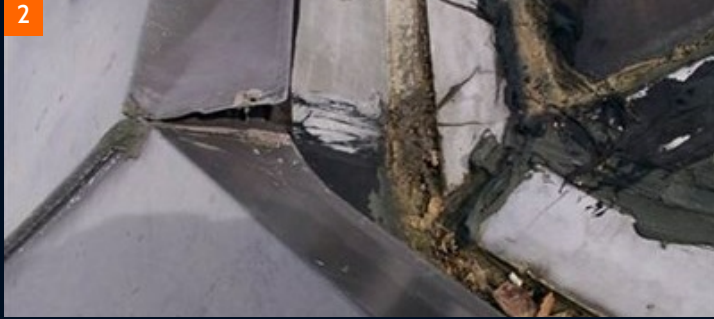
The skylights were situated over a major gathering area and presented a constant maintenance problem for many years. The leaks also created major safety issues and other problems
