# BELZONA SEALS EXPOSED PARKING DECK SEAMS

ID: 687

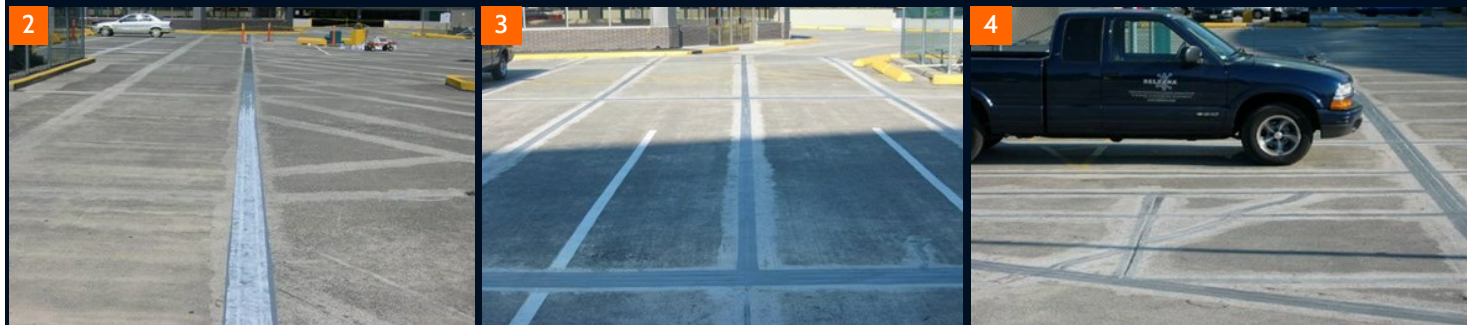
1. Initial test area after more than 2 years service
2. Application in progress - 1st coat with Reinforcement Sheet in place
3. Application of 2nd coat in progress
4. Completed section of deck

Test strips were installed at the site in 2000. Both 3111 and 3121 were submitted. Both products performed well showing no deterioration after 2 years. Belzona 3121 was chosen for its relative ease of application. Application has been spread over 3 years with a total of about 15,000 linear feet of seams completed
