# BELZONA PROTECTS 10,000 SQUARE FEET OF FLOORING

ID: 69

Chemical plant floor

Chemical Plant in Alabama

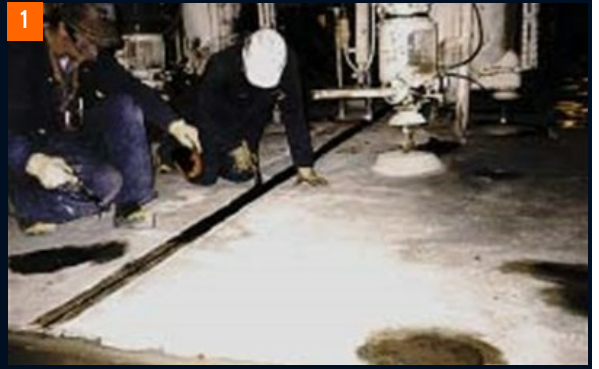
1. Bridging over expansion joint in accordance with modified Belzona application procedure TCC-12 with Belzona 2131.
2. First coat of Belzona 5811 applied with Belzona 9221 (Surefoot Aggregate White) broadcast for non-skid safety system. Application of second coat Belzona 5811 (tinted red) in progress.
3. The completed application, floor and ground protected from chemical degradation and contamination.
