# BELZONA PROTECTION TO FOAM GLASS INSULATION ON TANK

ID: 70

Foam glass insulation on roof of 70' diameter tank

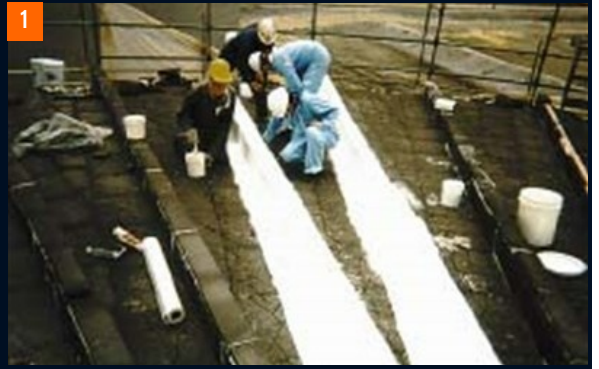
1. Application begins to the foam glass insulation.
2. Work in progress.
3. The finished application. Seamless encapsulation and waterproof protection to the insulation with Belzona 3211.
