# BELZONA KEEPS HISTORIC, 70-YEAR-OLD VESSEL STEAMING ON

ID: 7474

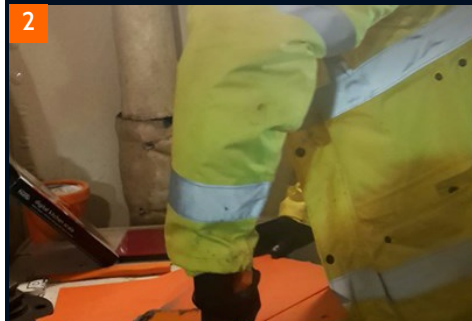
1. The PS Waverley is the last sea-going paddle steamer in the world
2. Mixing of Belzona 1511 (Super HT-Metal)
3. The solvent-free material was ideally suited for the confined environment on board
4. Application of the metal repair material to restore the pitted sections

In order to combat the high temperature environment, Belzona 1511 (Super HT-Metal) was used to rebuild the pitted areas, able to be hand-applied and solvent-free. Once cured, the metal repair material was machined down to be flush with the surrounding areas. This application was completed using a modified version of ENC-4 system leaflet.
