# COLD BONDING PIPE SUPPORTS WITH BELZONA

ID: 7476

Installation of new VOC treatment pipe rigs onto oil tanks.

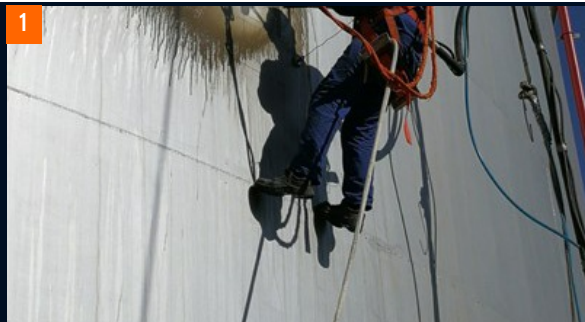
1. Water jet blasting for surface preparation
2. Application on top of the tank
3. Application on tank wall in process
4. Application completed

The application was carried out in accordance with Belzona Know-How System Leaflet TCC-6 and VPF-15. To ensure optimum bond whilst observing the safety requirements in the tank farm, surface preparation was conducted using water jet blasting equipment.
