# PRECISE ALIGNMENT APPLICATION WITH BELZONA 7111 IN COAL MINE

ID: 7498

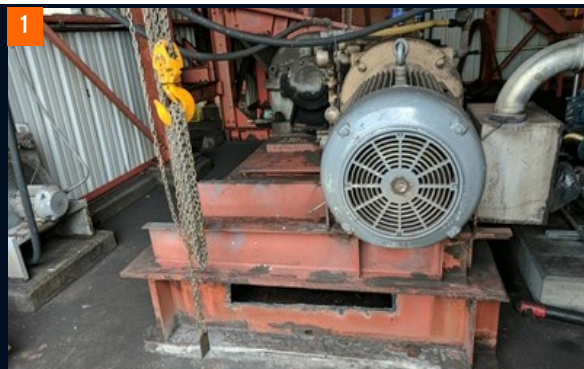
The mine was replacing six old conveyor belt drives with new units that achieve the same BTU with almost half the footprint. These drives had to be precisely aligned according to the alignment requirements from the manufacturer (Baldor Dodge).

- 1- Old CST Drive
- 2- Anchored Bolts with Belzona 4151
- 3- Pouring Belzona 7111
- 4- Finalized Application
