# BELZONA PROVIDES INTERNAL LINING TO NEW SLURRY THICKENER

ID: 7527

New construction slurry thickener 5 meters in diameter to be used to improve/renew part of production in a chemical plant.

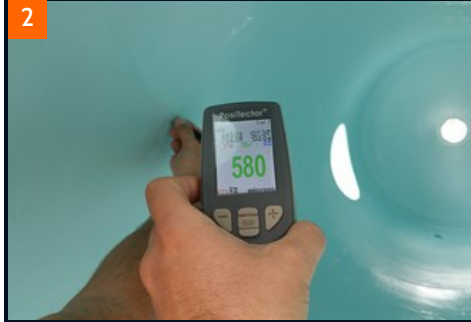
1. Internal view
2. DFT Inspection
3. Spark test
4. Completed application
