# PROTECTING HVAC DUCTWORK WITH BELZONA

ID: 7534

Solution required to seal and protect weathered ductwork insulation.

Insulated heating and ventilation ductwork on a university roof.

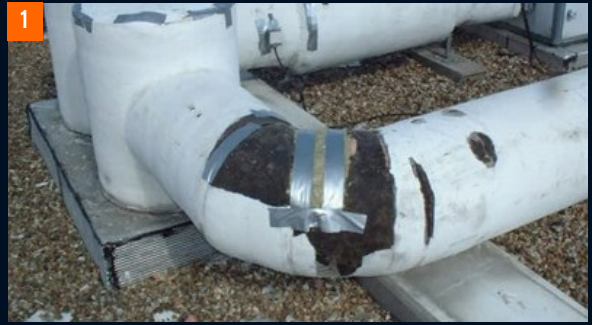
1. Damaged insulation 2. Close up of the damage 3. Belzona repair after 14 years in service 4. Belzona repair after 14 years in service

Application was carried out in accordance with Belzona System Leaflet VPF-12.

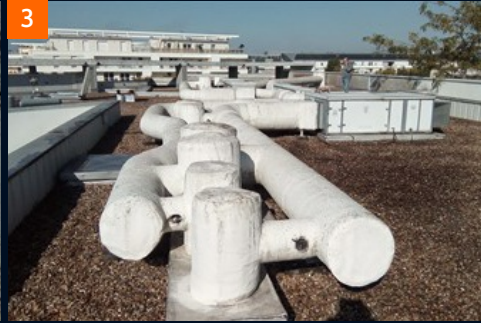
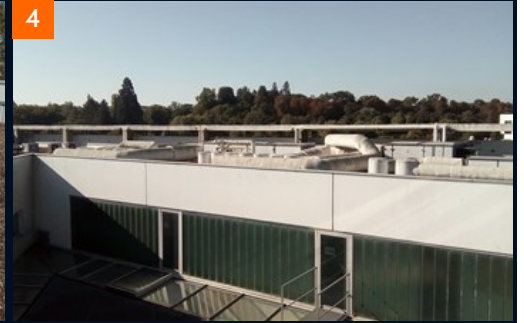
Belzona 3211 offers outstanding protection from the elements, including UV exposure. It is micro-porous and will prevent liquid from penetrating through it while allowing any moisture to evaporate, so maintaining thermal efficiency and reducing CUI. This application was photographed in 2017, after 14 years in service. Still in perfect condition.
