# MACHINE FOR CELLULOSE PRODUCTION LEVELLING

ID: 7621

Machine anchor and balance

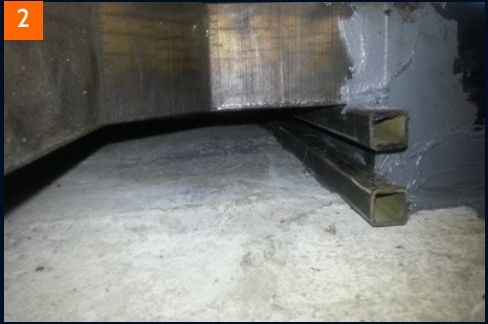
1. Bases of the machines have to be seated on the correct place
2. Every possible leakage had to be close
3. Injection
4. Ready to work

Bases of the machines have to be seated on the correct place, then Belzona 5811 was injected to fix the bases.
