# BELZONA REPAIRS VERTICAL SHAFT IN-SITU

ID: 7623

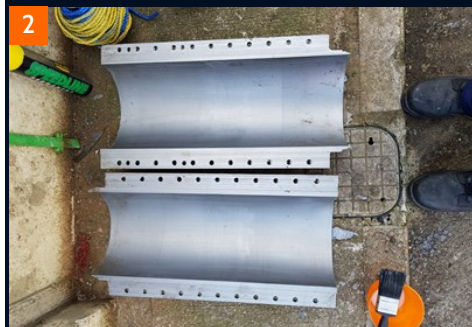
A D.T. Machine has a shaft that stands vertically between two floors, the vertical shaft which runs between the electric motor and the rotating element had deteriorated badly, due to erosion, causing a loss of product coming through the stuffing box area.

1. Shows Severely damaged vertical shaft
2. Pre-Machined formers
3. The product applied to the shaft with the former
4. Completed Application

The application was carried out in accordance with a modified version of Belzona Know How System leaflet FBC-13, a former had been pre-machined, coated with release agent. The surface of the shaft was prepared using grit blasting. Belzona 1511 was applied to the former and shaft, the shaft was aligned in position and tightened and left to cure. The next day the former was removed and the edges machined back, once this was completed, a force cure was used to further increase the temperature resistance of the Belzona 1511.
