# BELZONA COATS A LARGE CONDENSER IN A COAL FIRED POWER PLANT

ID: 7645

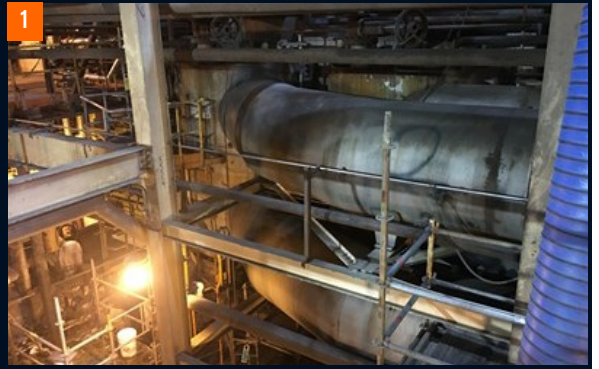
1. Left side quarter of each of two levels of the condenser.
2. Right side quarter. The other half of this condenser is in a separate room on the other side of the wall.
3. Heated plural component pump.
4. This shows about 1/4 or less of the hose needed to get from the pump on the catwalk to the application site. This proved to be too long and the spray application was abandoned for a hand application.

Belzona 1111 was used to fill in the rough and pitted areas. In order to be as economical as possible for the customer, Belzona 5811 was applied as the first coat. The top coat was Belzona 1341. The application was started using a heated plural component pump with insulated heated lines. Because of the length of the hoses needed to go from the catwalk where the pump was staged to the interior of the condenser, the product cooled too much before application so the contractor changed to a brush and roll method. The application was carried out in accordance with Belzona System Leaflet TCC-5.
