# BELZONA H<sub>2</sub>S PROTECTION AT A PUMP STATION

ID: 7664

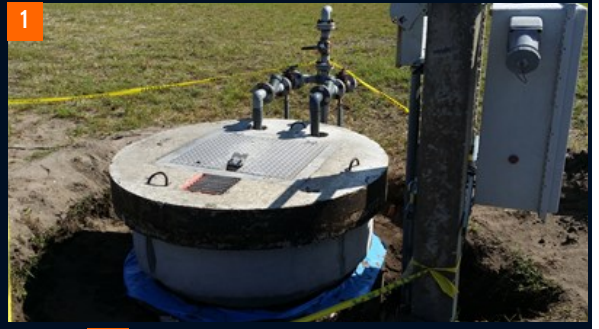
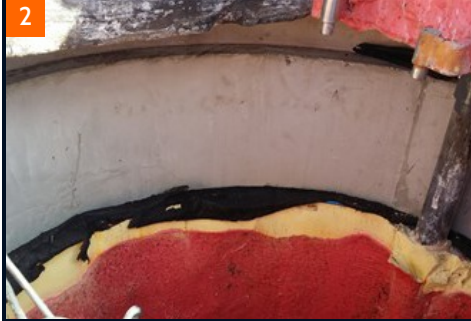
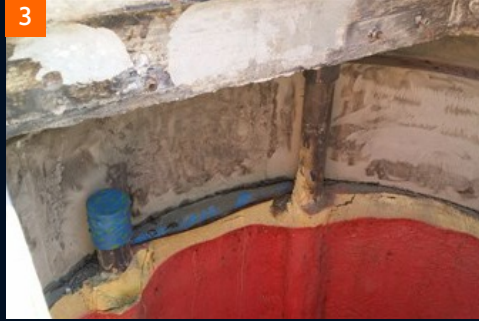
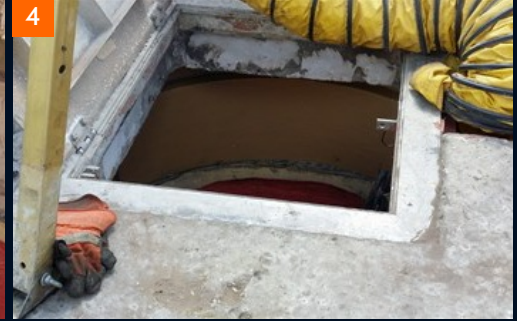
The Customer needed a protective coating to prevent H<sub>2</sub>S damage on a newly installed concrete ring at a pump station.

A new concrete ring installed to increase the height of a pump station to prevent stormwater from getting into the pump station.

The application was carried out in accordance with a modified version of Belzona Know-How System Leaflet VPF-14.

The concrete surface was prepared by scarification. Belzona 5811 (Immersion Grade) was applied to the entire repair area.
