# BELZONA EROSION-RESISTANT COATING FOR A KORT NOZZLE

ID: 7668

New kort nozzle on a tugboat.

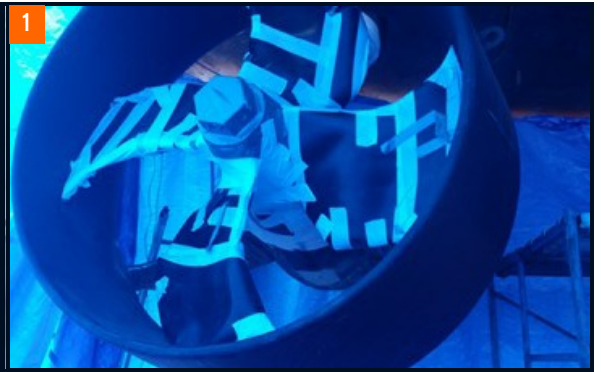
1. Kort nozzle ready to be abrasive blasted
2. Ridge line grinded to the inside of the kort nozzle to have the 1321 coating butt up against to prevent any delamination from happening.
3. Application of Belzona 1321
4. Outside view of the final coat of 1321 ceramic s metal.

The applicaiton was carried out in accordance with a modified version of Belzona Know-How System Leaflet SOS-2. The nozzles, arms, lower pod and up the neck area were abrasive blasted. Belzona 1311 was applied to the various areas to cover the welds and sharp edges along the strut arms and areas up the neck. Belzona 1321 was applied to the entire drive unit an nozzle in two coats.
