# BELZONA SPIN SPRAY APPLIED PROTECTIVE COATING FOR SCRAPER TRAPS

Scraper traps, that launch and receive scrapers/pigs when the crude oil pipeline is being cleaned, required corrosion protection.

A new HT crude oil transfer pipeline is being installed at an oilfield in Saudi Arabia. Belzona 1391S has been specified for the protection of 12 newly fabricated scraper traps, following a process vessels lining spec for the same customer.

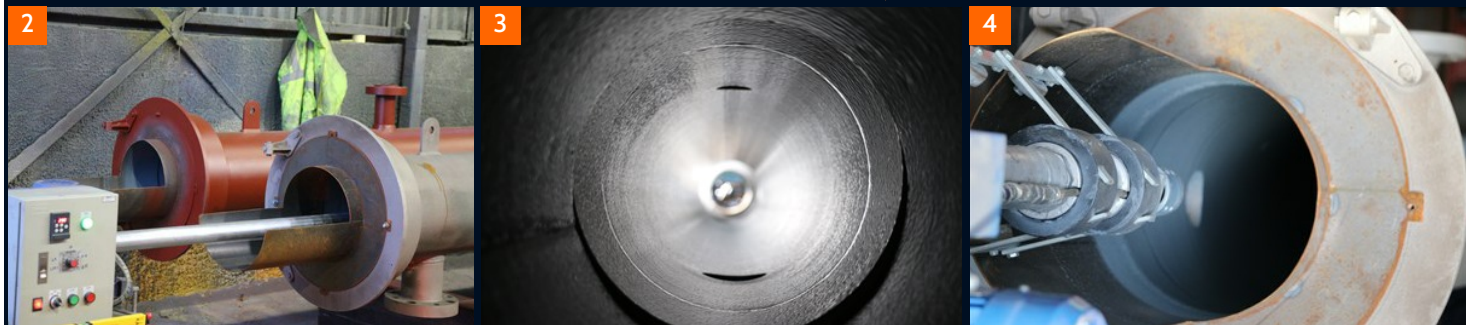
1. Scraper trap prior to application.
2. Calibration.
3. First coat applied.
4. Application complete.

Application was carried out in accordance with Belzona Know-How System Leaflet VPF-2 using spin spray application equipment.
