# BELZONA PLATE BONDING APPLICATION HELPS A MILITARY VESSEL DEPLOY ON SCHEDULE

ID: 7686

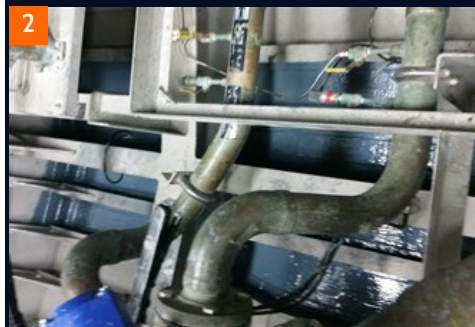
Water was leaking into two compartments, located against the aluminum hull of the ship (approximately 400 Square Feet of total repair area). The shell of the hull and stiffeners in the spaces were corroding from salt water, which was collecting in lower reaches of the space. The corrosion had progressed to the point that the water was leaking and traveling into adjacent hull locations. Stitch welding of the vertical stiffeners to the shell was hiding much of the corrosion.

1. Showing damage caused by corrosion.
2. 1st coat of Belzona 1321 applied.
3. Doubler plates embedded with Belzona 1111.
4. Complete application.

The application was carried out in accordance with a modified version of Belzona Know-How System Leaflet SOS-1, SOS-2. Belzona 1111 was applied to prepared substrate and prepared plates – to bond doubler plates to the shell, the bulkhead and into the corners with 90 Degree angle plates. A top coat of Belzona 1321 was applied to all repair areas – to allow for easier inspection of the repairs and to provide a more professional appearance of the completed repair area.
