# BELZONA REPAIRS A HEAVILY DAMAGED MARINE FENDER

ID: 7723

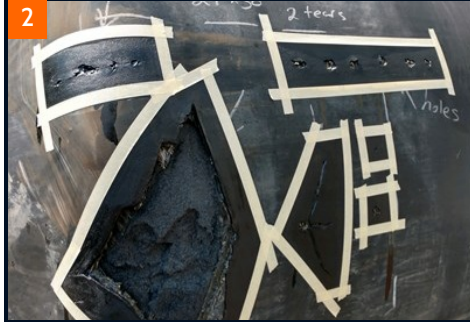
Something sharp impacted these fenders hard enough to rip and tear through the 1.5" heavy duty rubber. This would allow water to saturate the foam core which in turn will cause the fender to sink rather than float

1. Original damage.
2. Prepped, conditioned, and taped.
3. Applying the Belzona 2111 D&A Hi-Build Elastomer.
4. Completed application.

The application was carried out in accordance with Belzona System Leaflet SOS-12. First, all loose and damaged areas and pieces were removed. The surface was then prepared with an MBX Bristleblaster to a nice rough "feathery" finish. Belzona 2911 was then applied to the prepped area and then taped off to provide clean lines for the repair. Belzona 2111 was mixed, 500 gr unit at a time, and allowed to cure as per the Instructions For Use. It was then worked into the surface and built up to bring it back to its original form. Finally, each location was overlaid with Belzona 9341 to give the repair some added strength. The tape was removed and the application was smoothed by a Belzona applicator.
