# PROTECTION OF NEW VERTICAL PUMP FOR POTABLE WATER SERVICE

ID: 7733

Pump lining application to protect a new build vertical pump to supply potable water for a local water district in Texas, USA.

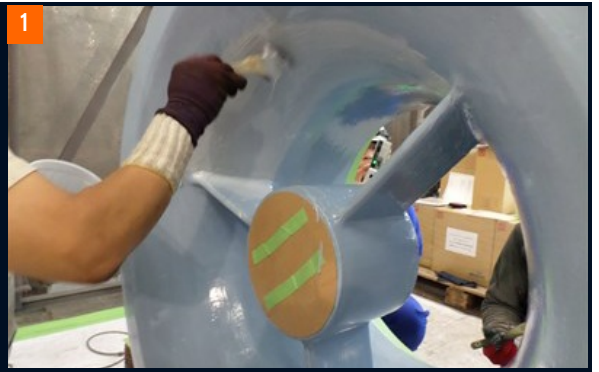
1. Application of 2nd coat on the Suction Bell
2. Spark testing the Suction Bell
3. Suction Bell completed
4. Discharge Bowl completed

Application was carried out in accordance with Belzona Know-How System Leaflet CEP-3, at the fabrication site of pump manufacturer in Japan. A suction bell and a discharge bowl were blasted and coated with NSF approved Belzona® 1341 internally. Blow holes found were filled with Belzona® 1111 to achieve smooth surfaces prior to the final coat of Belzona® 1341.
