# COOLING TOWER PROTECTED THANKS TO BELZONA

ID: 7734

General corrosion of the concrete basin

Cooling water basin

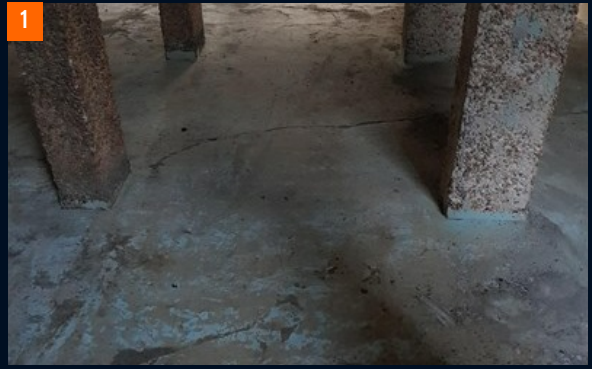
- 1- Corrosion of the concrete and exposed steel re-bar
- 2- Repair of the concrete work using Belzona 4111
- 3- Work completed with application of belzona 5811
- 4- Work completed
