# BELZONA 3111 TO WATERPROOF A STUNNING NEW BUILD DEVELOPMENT

ID: 7742

Three new builds required a water and weatherproofing system for a surface area of 2700m<sup>2</sup> (29,000ft<sup>2</sup>)

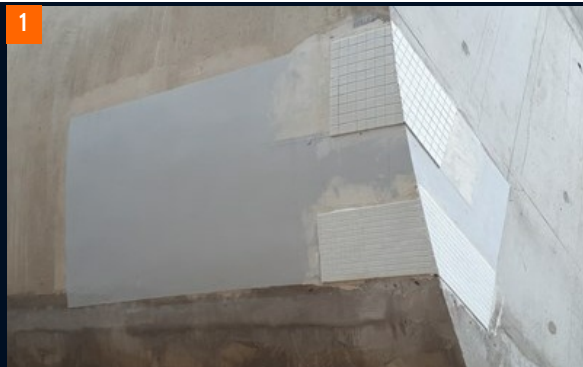
1 - A close up of the Belzona 3111 with the tiles bonded on top

Belzona 3111 was rolled onto the roof to completely encapsulate it. Then it was overcoated with an adhesive to bond the tiles.

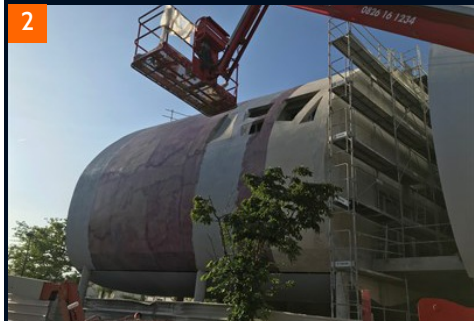
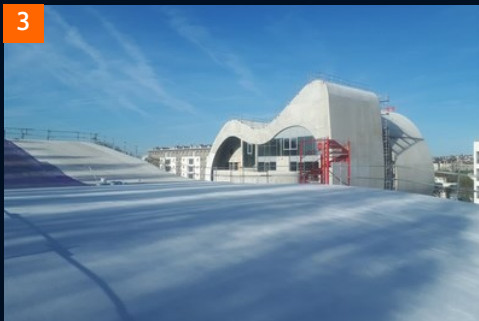
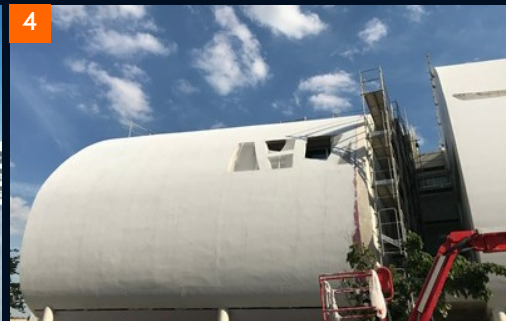
2 to 4 - Application in progress
