# BELZONA 5122 CLADDING PROTECTS A BRICK AND MASONRY STRUCTURE AT A UNIVERSITY BASEBALL STADIUM

ID: 7759

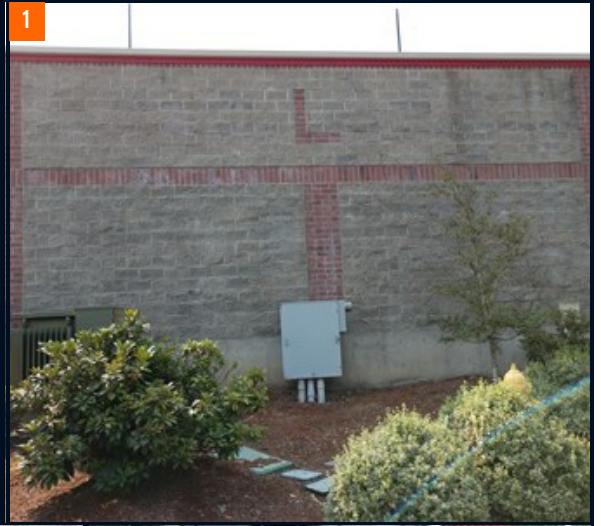
The wall needing protection from water penetration

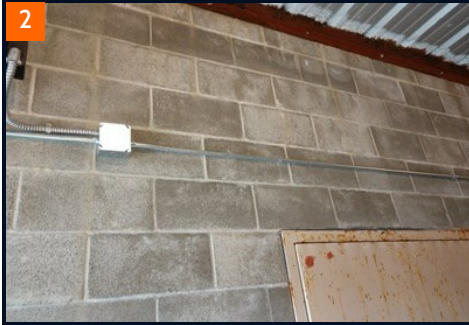
Corrosion had begun to degrade the internals and threatened damage to electronics

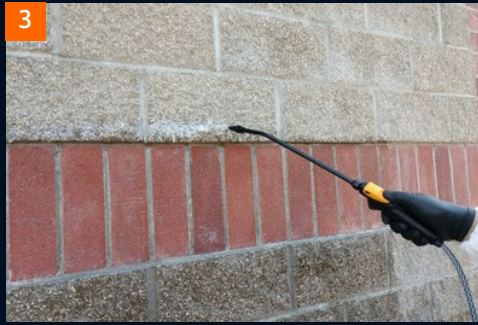
Application of Belzona 5122

Belzona 5122 was applied in accordance to WPA-8 Belzona Know-How System Leaflet. The surface was pressure washed to remove algae, moss, and dirt and allowed to dry. Belzona 5122 was then mixed and put into a standard garden sprayer. Belzona 5122 solution was then sprayed via the garden sprayer to the concrete, cinder blocks, and brick from the bottom up allowing excess to flood the previously coated areas.

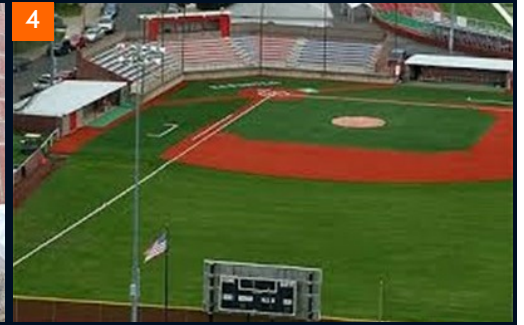
Stadium protected and ready for the games
