# BELZONA ELASTOMER SEALS CHAIN PLATE CASING ON NEW YACHT

Chain plate casings on a new luxury yacht under construction

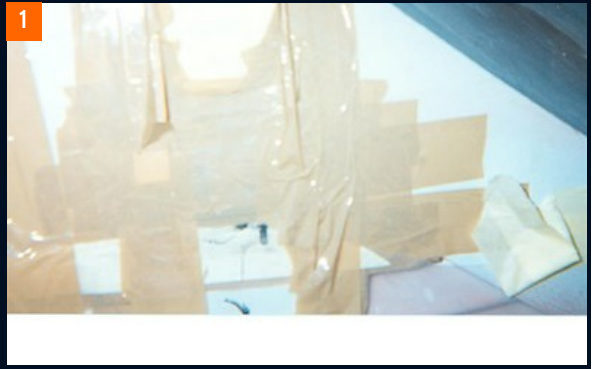
1. Tape used to contain Belzona during the pouring operation
2. The chain plate pocket sealed with Belzona 2131
3. Close up showing neat Belzona seal created

Application was carried out in accordance with Belzona Know-How Sysystem Leaflet GSS-4. As the application was partly vertical, tape was used to create a dam to enable the Belzona Elastomer to be poured into place.
