# BELZONA'S PREVENTIVE PROTECTION FOR A GEOTHERMAL PLANT CYCLONE

Preventive application on a cyclone in a geothermal plant.

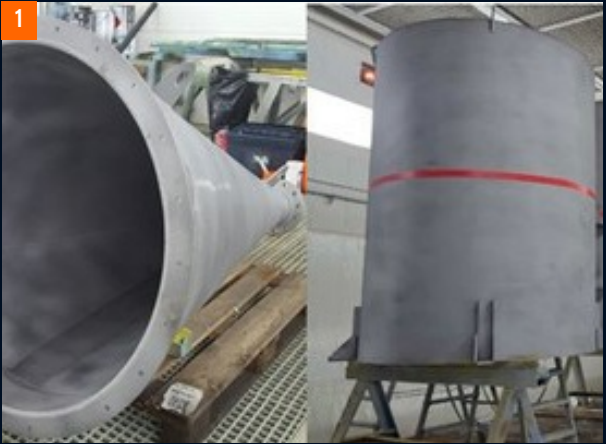
Equipment overview after grit blasting.

The steel was grit blasted first, then all the surfaces in contact with brine and the inside of the exhausts were coated with Belzona 5892. Belzona 1523 was then used for the protection of the parts exposed to important erosion and high temperatures.

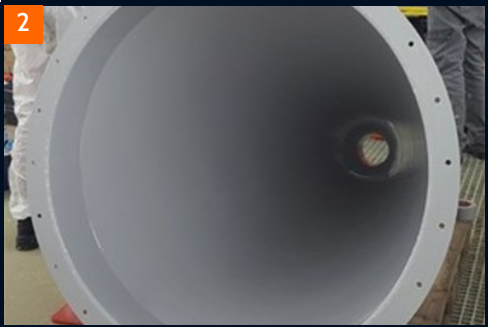
Protection with Belzona 1523.

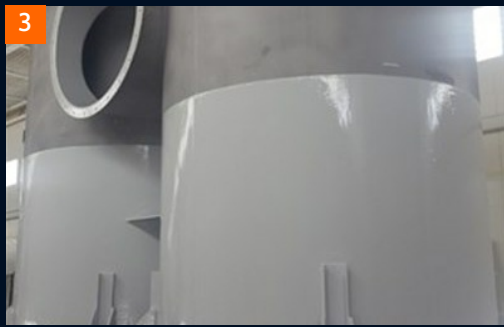
Protection with Belzona 5892.

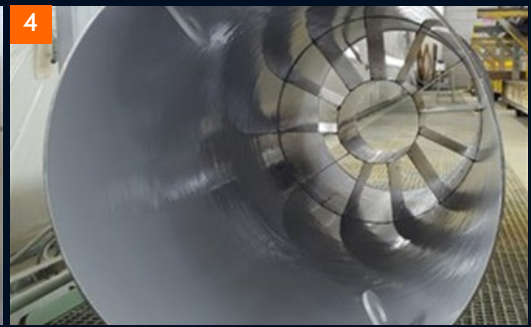
Protection with Belzona 5892.
