# CREATING NON-SLIP DIVING BOARDS WITH BELZONA

ID: 7783

Aquatic Center, KS, USA

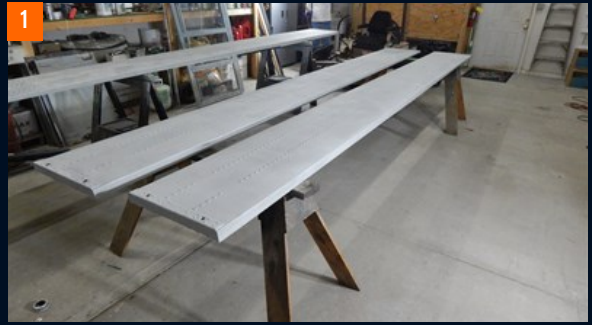
Surface after being blasted.

Application was carried in accordance with a modified version of Belzona Know-How System Leaflet FPA-8. The boards were sandblasted to remove all of the old coating and provide an excellent profile for the new application. After the boards were sandblasted they were vacuumed and washed with acetone. The boards were then coated with Belzona 5811. Belzona 9221 was heavily sprinkled across the tops of all the boards and then back rolled to ensure an even application of the aggregate and most importantly to encapsulate the aggregate granules. Encapsulating Belzona 9221 ensures that the application last longer by keeping the sure foot trapped with the coating rather than wearing or rubbing off or level. However this is also done to put a very thin layer of Belzona 5811 over the top of the granules to smooth out sharp edges so that they would not cut the feet of anyone using the boards.

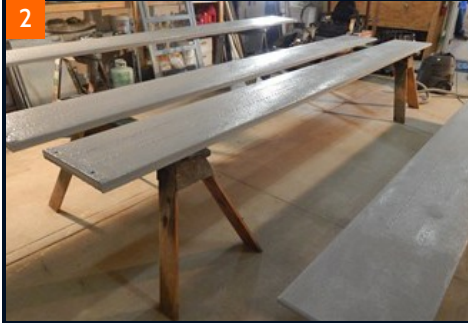
Finished application of the second coat.

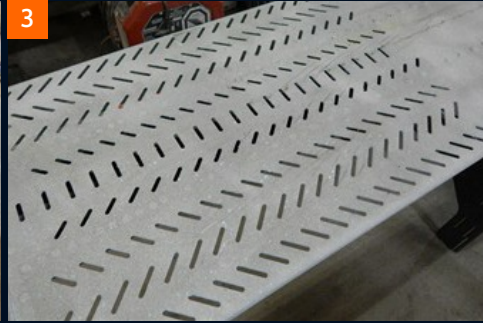
Surface after being blasted.

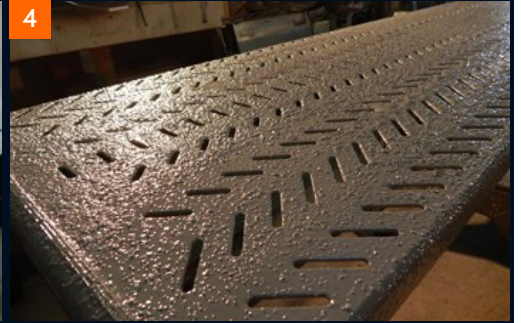
Finished application of the second coat.
