# BELZONA SPHERE LINING ROLLED OUT

ID: 7847

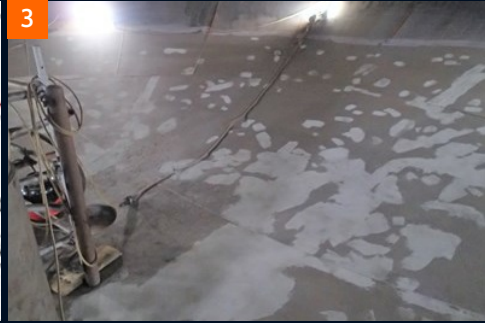
Lowest section filled with Belzona 1111.

Prequalification trials proved the Belzona 4311 could be sprayed using plural feed equipment and the first sphere was coated in 2010, in accordance with a modified version of Belzona Know-How System Leaflet TCC-5. Small bore nozzle inserts were installed using a modified version of Belzona Know-How System Leaflet TCC-16a.

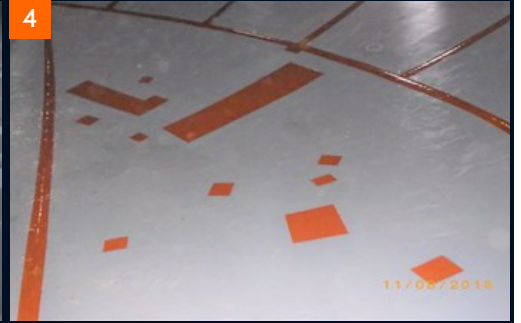
Lowest section completed with Belzona 4311.
